The above and following photos were captured from videotape of crash tests performed on April 6-7, 1999. Two identical 1996 Ford Taurus GL models were used in these tests. One vehicle had original manufacturer hood and fender; one vehicle had a CAPA certified hood and left fender installed.

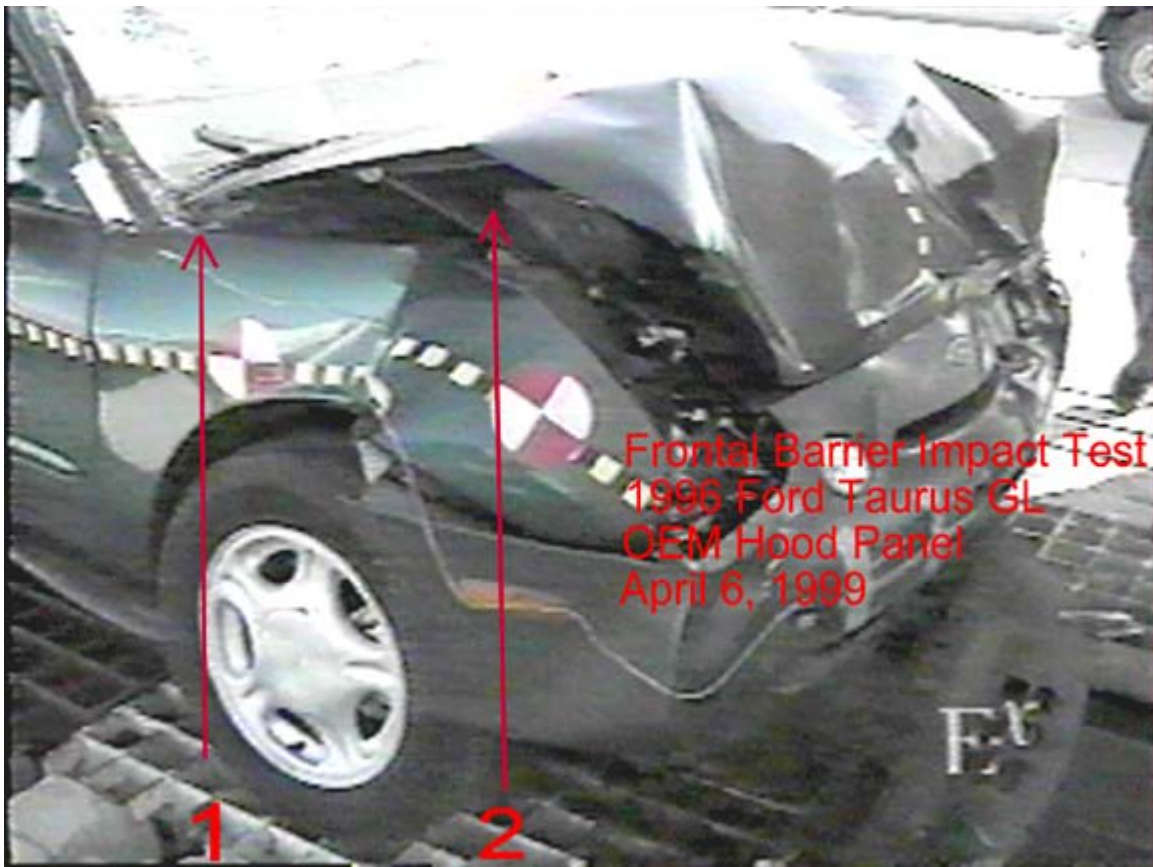
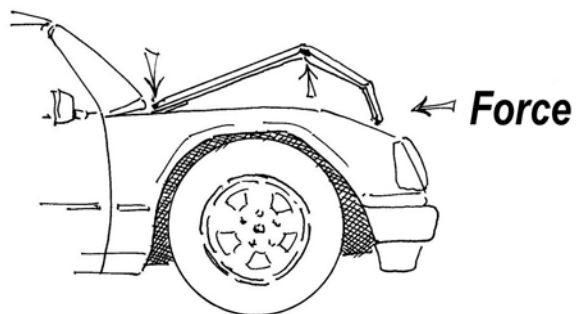
The first vehicle tested (pictured above) retained the original factory hood and fender. From these photos it appears that the hood performed as designed in that the hinge area (1) retained contact with the hinge plate and the hood "tented" (2) absorbing energy forward of this area.

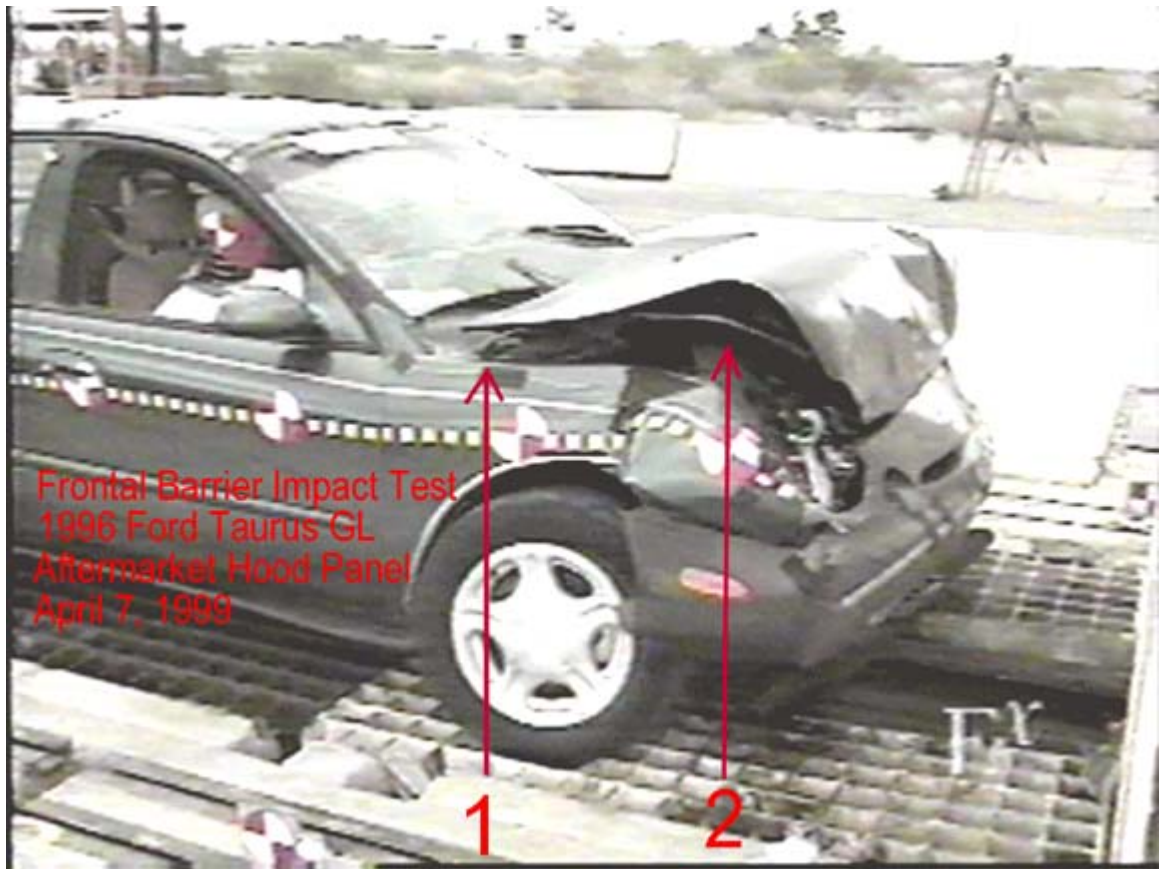
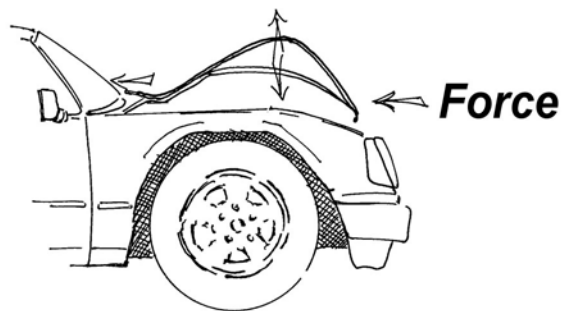
The above test performed on April 7, 1999 used the vehicle in which a CAPA certified hood and left fender were installed. In this crash test, the hood performed in a different manner than the previous test using OEM parts. The hinge area (1) raised significantly higher than the OEM, and the inner frame of the hood separated (2) allowing uncontrolled transfer of energy over the entire panel.

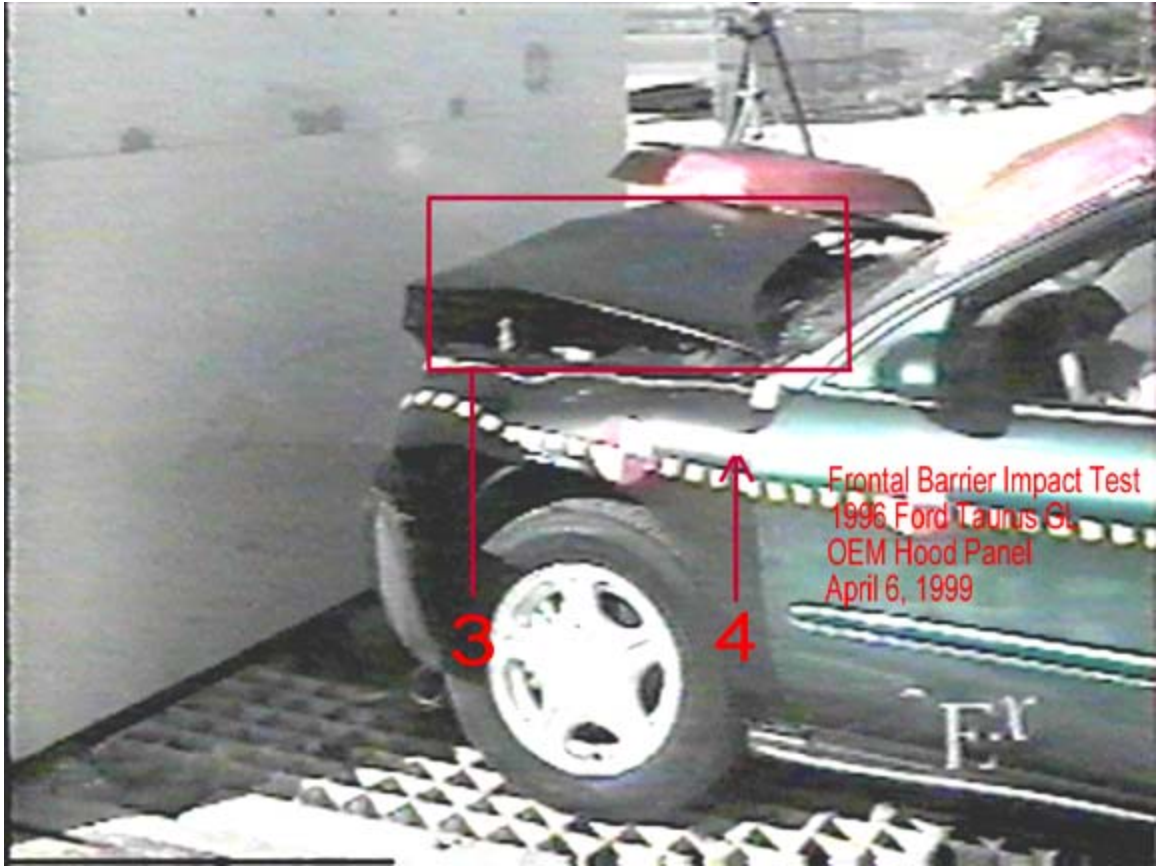
This photo is of the vehicle with OEM hood and left fender from the opposite side after impact. Note the sharp angles and relatively flat areas pictured (3), which indicate the factory designed “darts” performed as designed.

The left hinge area and rear fender (4) are consistent with the damage on the right side.

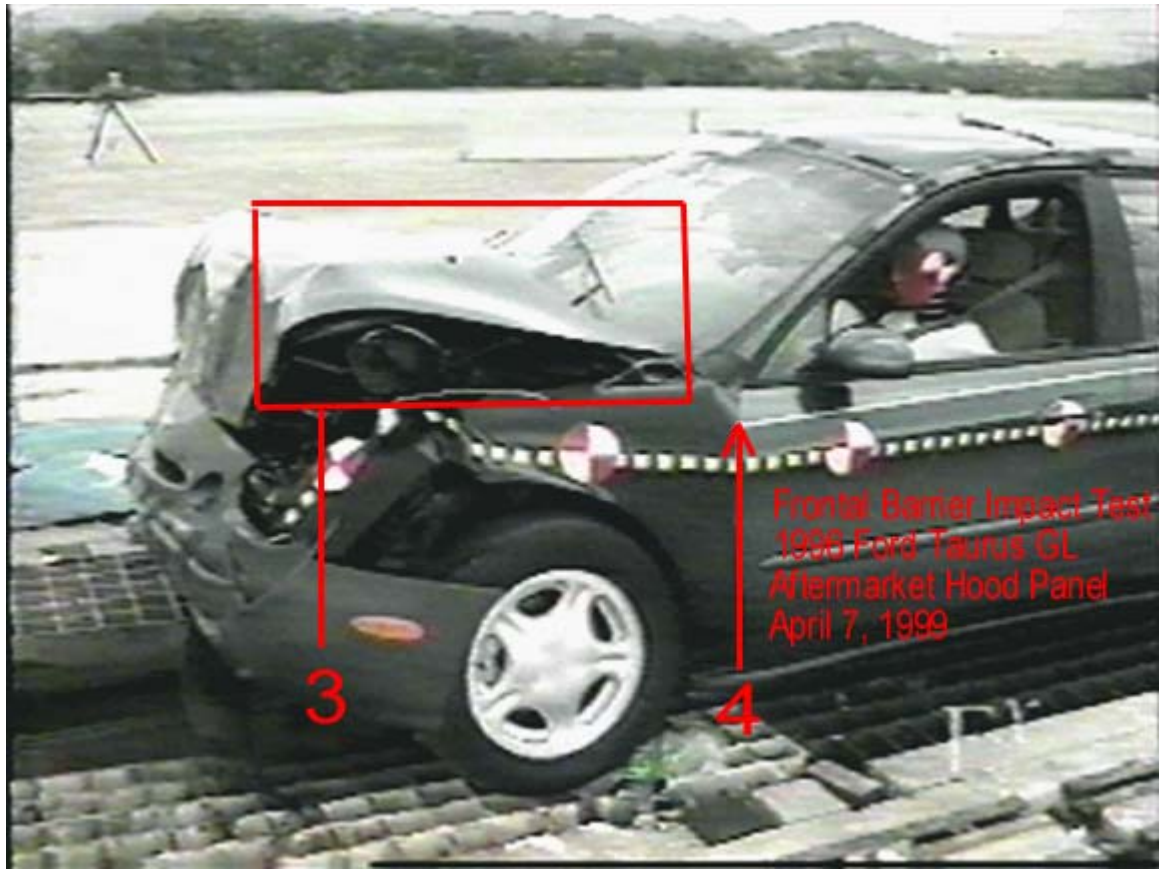
This photo is of the Ford Taurus on which aftermarket body parts were installed. Note the uneven distortion on the rear of the hood (3), and the damage to the rear of the aftermarket fender against drivers' door, which does not appear on the three OEM fenders, which were involved in these tests.
